Application of Six Sigma Methods to Quality Improvement in Generator Sets

Keywords: generator sets; six sigma; quality improvement

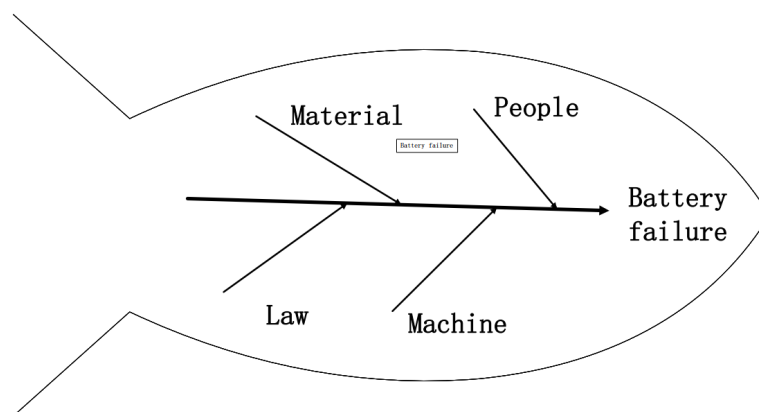
Figure 4 Fishbone diagram of battery failure

Often the unit will not start because the battery has failed and is unable to provide sufficient power for the genset to start. The battery failure mode is analyzed by using the method of fishbone diagram, which is based on four aspects: man, machine, material and method.

People: terminal post false connection or rain cap installation is not in place to cause terminal post oxidation. Terminal block protective cap is not installed in place to cause rain erosion and rust. Terminal block false connection will cause current sparking, will accelerate the terminal block corrosion, in the equipment operation soon after the loss of function.

Machine: Installation equipment failure or installation equipment model and battery terminal model does not match the battery false connection.

Material: The company has formulated a certain reasonable amount of product reserves in response to the cyclical of the industry. The equipment in stock was not concerned about the life and condition of its batteries during the conversion process, and long-term storage caused the batteries to lose power. They were not charged or replaced before leaving the factory, resulting in insufficient starting voltage for the equipment to provide sufficient power for the starter of the internal combustion engine.

Law: The process documentation does not specify the self-inspection requirements for the process. Resulting in unqualified flow into the subsequent process.

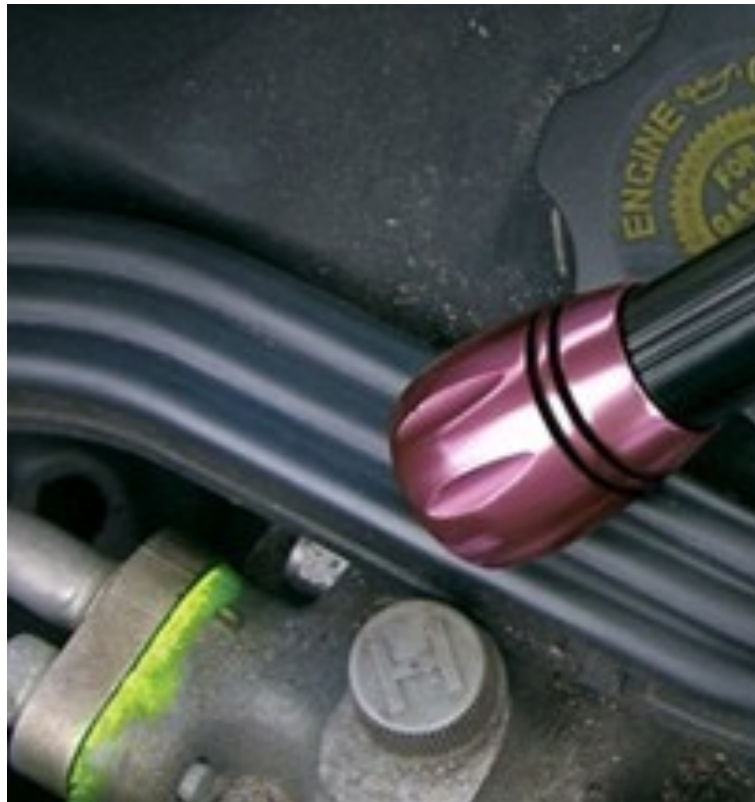
Figure 5 Fluorescence reflection of oil-based fluorescent agent under violet lamp

For engine body and pipeline oil leakage, we add 0.2% of 131SC oil-soluble fluorescent agent to the engine oil and then irradiate it with high-intensity black light (invisible ultraviolet or infrared rays), the dye will fluoresce strongly in yellowish-white color, and the leakage will be easily detected. Figure 5 show the fluorescence reflection of oil-based fluorescent agent under violet lamp.

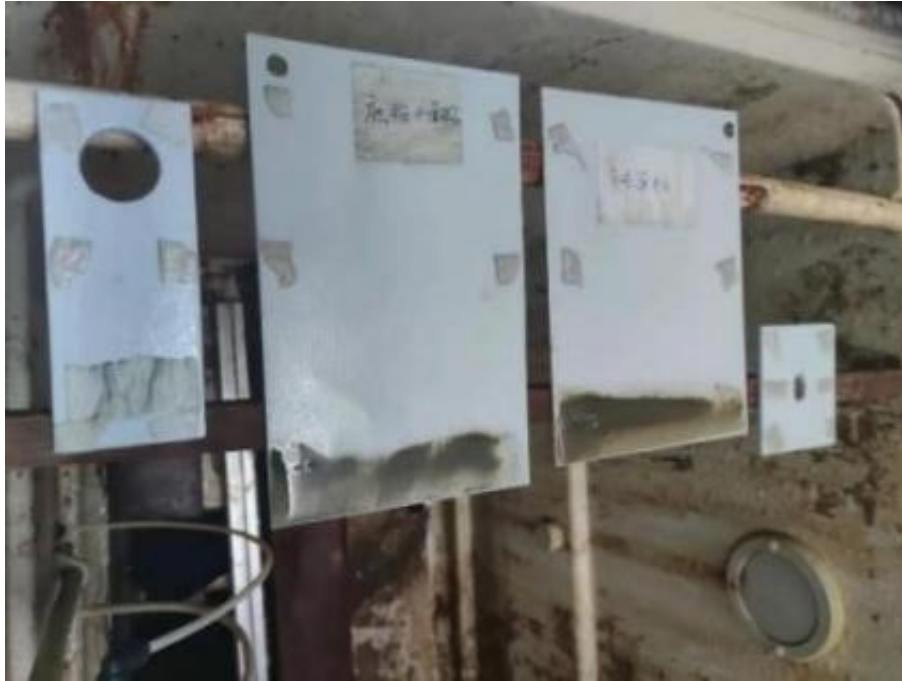
Figure 6 Medium-sized salt spray test for different parts of plates

Process according to GB/T 9271-2008 requirements. Take sheet metal parts in different locations of the equipment expansion body, respectively, single-layer zinc-rich primer (Group A) and double-layer zinc-rich primer (Group B), and carry out 1500 hours of neutral salt spray test. Adopt the method of Table 1 to observe whether blistering, wrinkling, rusting and peeling. Figure 6 shows the photographs of the medium-sized salt spray test performed on different parts of the plate.

According to the chi-square test of the data in Table 2, the experimental results proved that the number of zinc-rich primer layers is the main factor affecting the corrosion of the generator set cabin. Increasing the number of zinc-rich primer layers can effectively avoid the rusting of sheet metal parts in the salt spray environment.
